Equal Distribution of Weight Crosswise of Car

This general safety advisory broadcast is intended for all CPR Carload customers in Canada and the United States to address a significant increase of laterally imbalanced carload shipments detected by our Mechanical Services Department during our routine safety in-transit inspections.

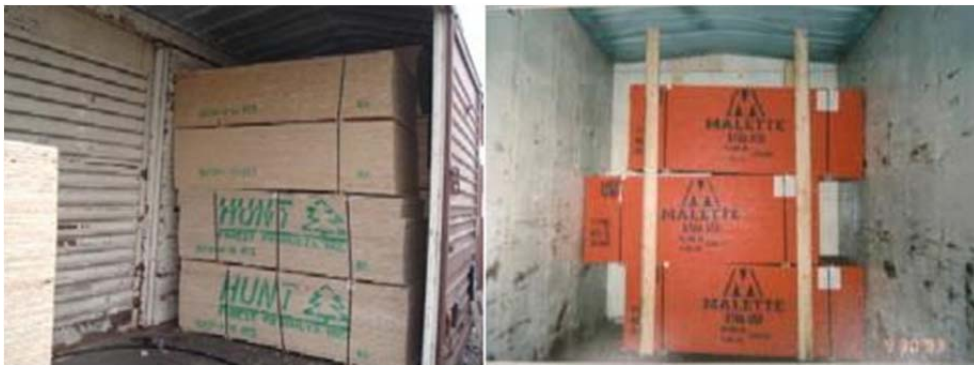
Canadian Pacific Railway's Damage Prevention Claim Services, and Mechanical Services Departments remind all carload customers to ensure that all loads prepared for rail departure are equally balanced. Failing to adhere to this mandatory requirement was deemed to be the primary cause of a recent derailment in British Columbia whereby a laterally unbalanced load caused a railcar truck restriction and permitted wheel lift over the top rail.

Incorrect Crosswise Distribution Of Weight (above left): photo depicts 4'x 8' sheets of board product loaded down the center of the boxcar with no protection offered to avoid against shifting into the lateral voids. As car travels natural vibration found in rail transit will

cause load to shift creating an imbalanced load.

Correct Crosswise Distribution Of Weight (above right): photo depicts bundles of 4'x 8' sheets of OSB, loaded to equally fill the 18 inch lateral void present in a 9'-6" wide boxcar. By "tipping up" the lifts as they are stacked in the car and supporting with a board placed between the lifts, as well having the runner boards present along the bottom of each lift placed at the top edge of the lift directly underneath tends to work at locking in the lifts as loaded creating an equal distribution of weight.

This advisory is intended to remind all CPR carload customers they **MUST** comply with all 10 mandatory general loading rules found in AAR (Association of American Railroads) Circular No. 42-J Issued January 1, 2001. Specifically, rule 5 is appended for clarification purposes:

Rule No. 5 - Distribution of Weight – Crosswise of Car

1. The load must be located so that the weight along both sides of car is equal for the entire length of the load.
2. When the load is of such a character that it cannot be placed so as to obtain equal distribution of weight, crosswise of car, suitable ballast, properly secured, must be used to equalize the weight.
3. In boxcars lading must be secured to prevent tipping or moving towards car's sides where the vacant space across car exceed the following:
 - An aggregate of 18 inches crosswise of car
 - Vacant crosswise space of less than 18 inches as may be specified in pamphlets covering methods for loading, bracing and blocking carload shipments of individual commodities
